DRAFT TEN-YEAR PERMACULTURE AND RESTORATION ECOLOGY PLAN FOR ALMUNYAH DE LAS DOS ACEQUIAS, HOME OF THE ACEQUIA INSTITUTE

Prepared by Devon G. Peña, Ph.D. - President and Co-Founder

August 2010

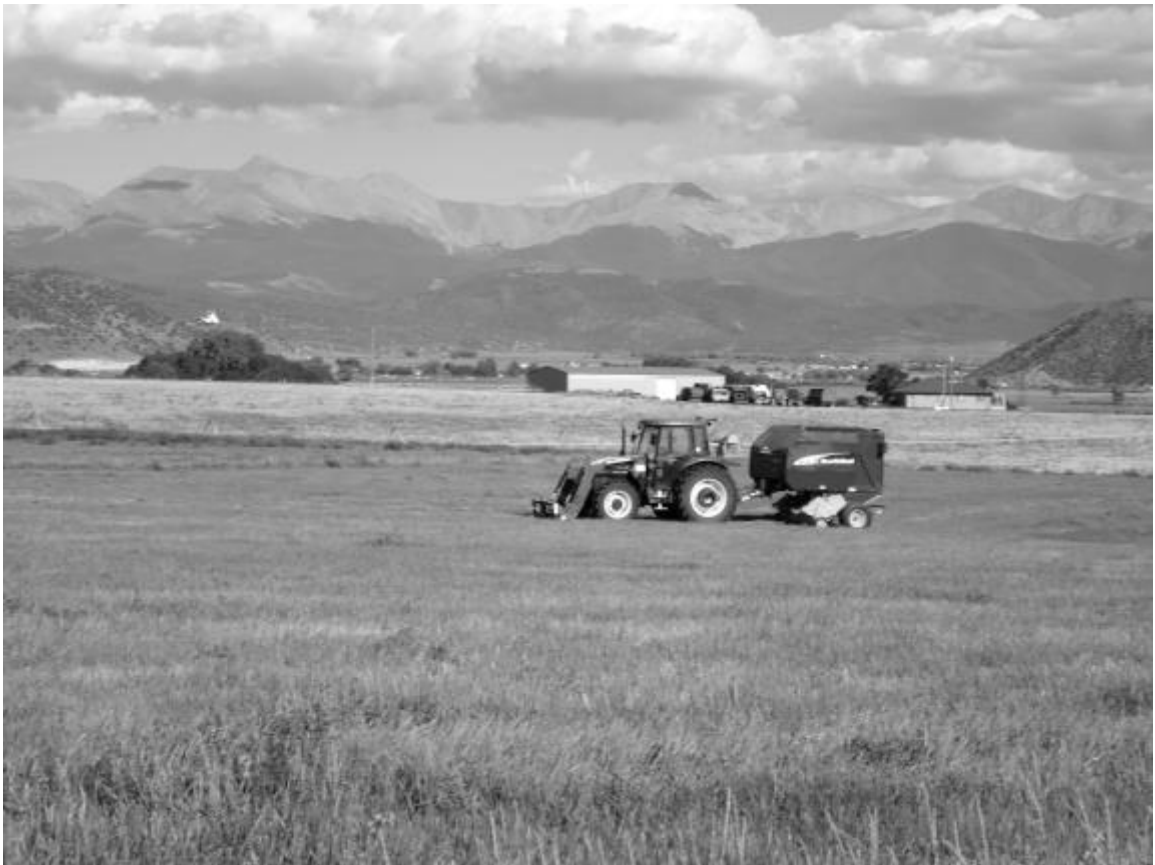
Figure 1. New Holland tractor and round baler during baling operations in the north-end fields.

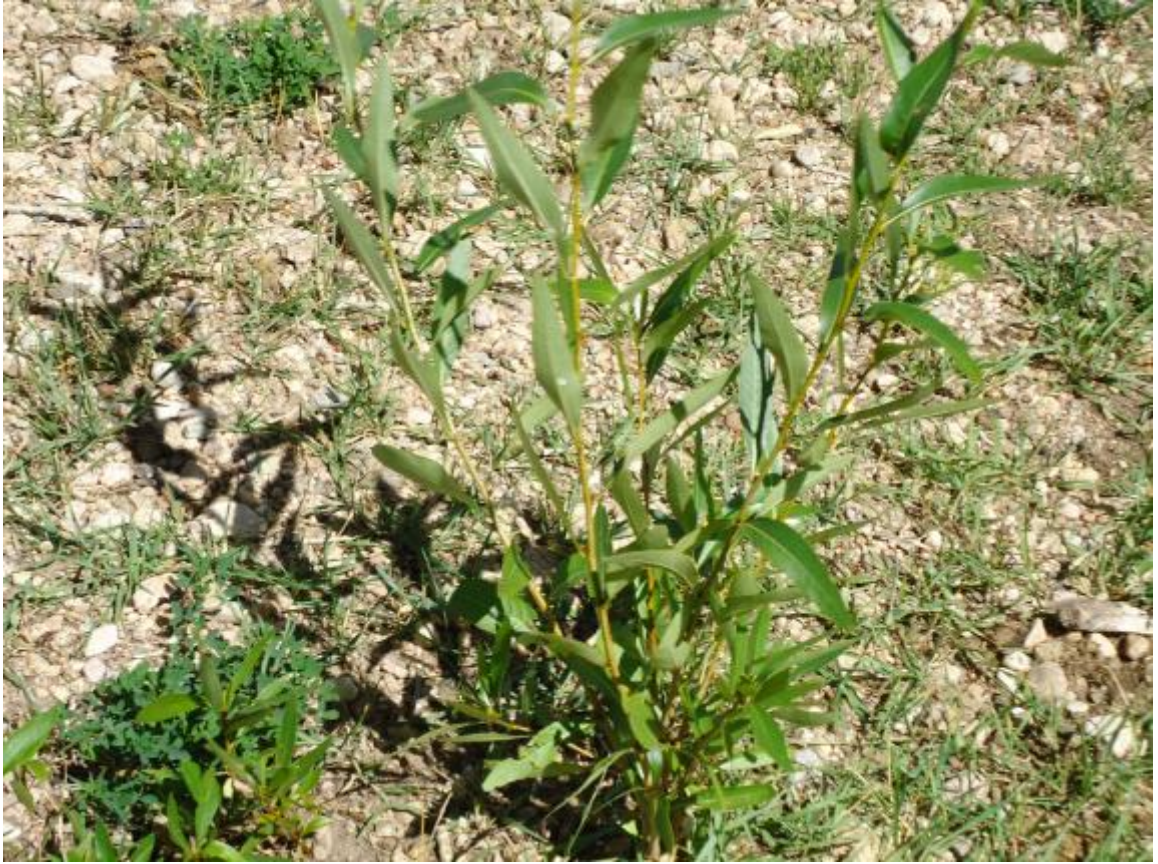
Figure 2. Cottonwood sapling in the bosque.

designs should this approach prove inadequate or inappropriate. On the habitat restoration front, we have reinforced cross-fencing and restricted livestock access to the riparian zone. Evidence of bosque regeneration is plentiful as can be seen in the Photographic addenda ([Appendix 2](#) below).

3. Management Changes. The principal management shift is our near total exclusion of livestock, and especially cattle and sheep, from the riparian zone where the problems of riverbank erosion and decline of the cottonwoods are critical concerns. Regeneration of the bosque and stabilization of riverbanks is readily apparent. We appear to be going in the right direction but will have to make sure that Jerry Gallegos, the current grazing leaseholder, manages the bull population for winter grazing in a manner that does not allow for intrusions into the bosque or excessive riverbank disturbances in areas deemed to be under recovery status.

1. Riparian Zone: Maintain livestock restrictions in perpetuity. Plant native willows and encourage cottonwood sapling regeneration on eroded riverbanks and adjoining riparian areas. Build cross fencing north of the river, “paddock islands” around regenerating areas to protect saplings and juvenile trees, and re-build and repair cross fencing south of the river. Re-build and extend cross-fencing to protect meanders. Construct “rip-rap” structures on more severely eroded riverbanks and areas where the river is naturally exerting pressure on bank stability and add structures to create fish habitat and slow river flow impact on eroded and vulnerable banks. Plant aspen, chokecherry, gooseberry, and piñon trees to increase species and structural diversity of the bosque area.

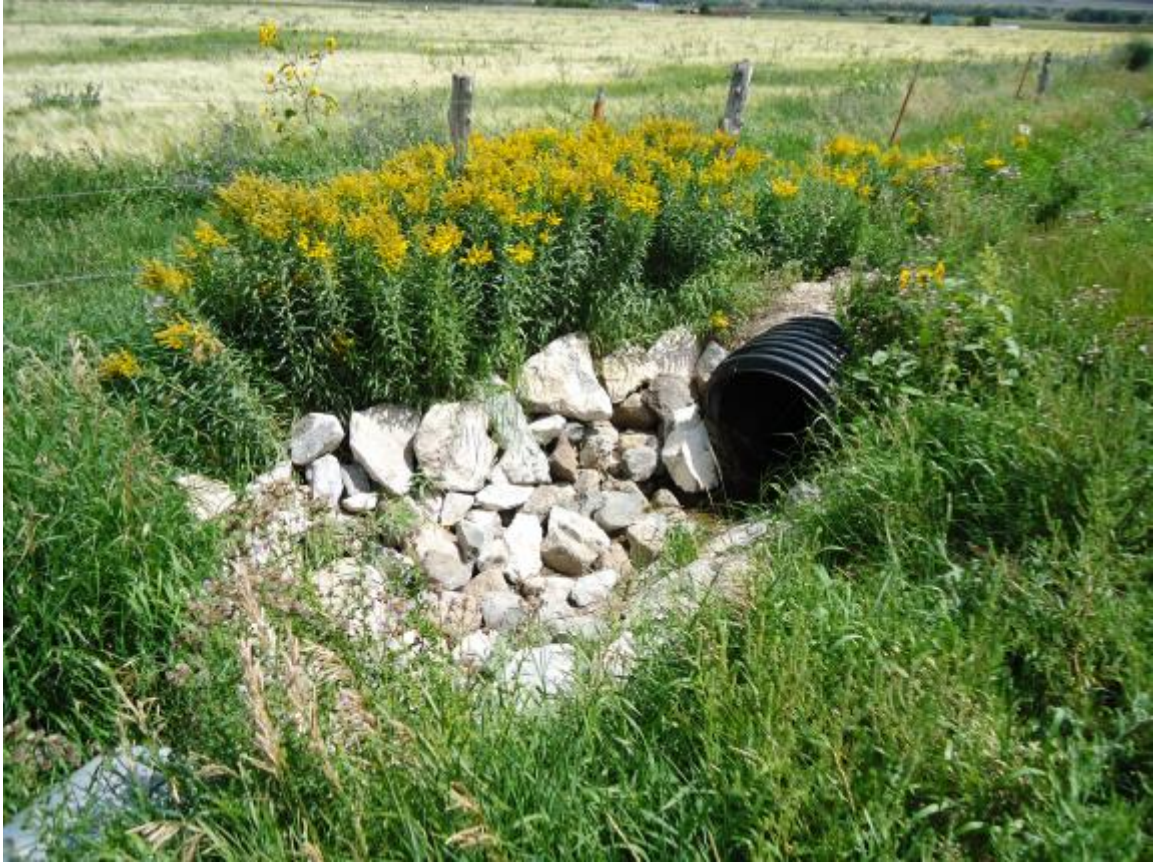
4. Head Gates off the San Luis Peoples Ditch: Another problem area we identified involves soil erosion control problems on two of the four main head gates off the main stem San Luis Peoples' Ditch at the northern end of the ranch. The eastside lateral ditch or lindero is a principal problem in this regard and we found it was experiencing significant back-wall erosion from the tremendous hydrostatic pressure of the water leaving the Peoples' Ditch and entering into the lindero that delivers water to a large alfalfa-native grass meadow we use to produce a good portion of our hay.

Figure 3. Newly completed rock structure on eastside lindero.

2. Experiments. We have developed two experimental strategies for dealing with soil erosion and habitat restoration and management challenges. On the soil erosion front, we have finally completed construction of a rock-lined compuerta structure on the problematic eastside lindero. We will observe how this works over the next two years and then decide an alternate

4. Head Gates off the San Luis Peoples Ditch: Re-assess rock structures in two years (2012) before proceeding with possible EQIP (or other) grants with NRCS to install more complete metal structures on all four headgates off the San Luis Peoples’ Ditch. Re-ditch the eastside and westside linderos.

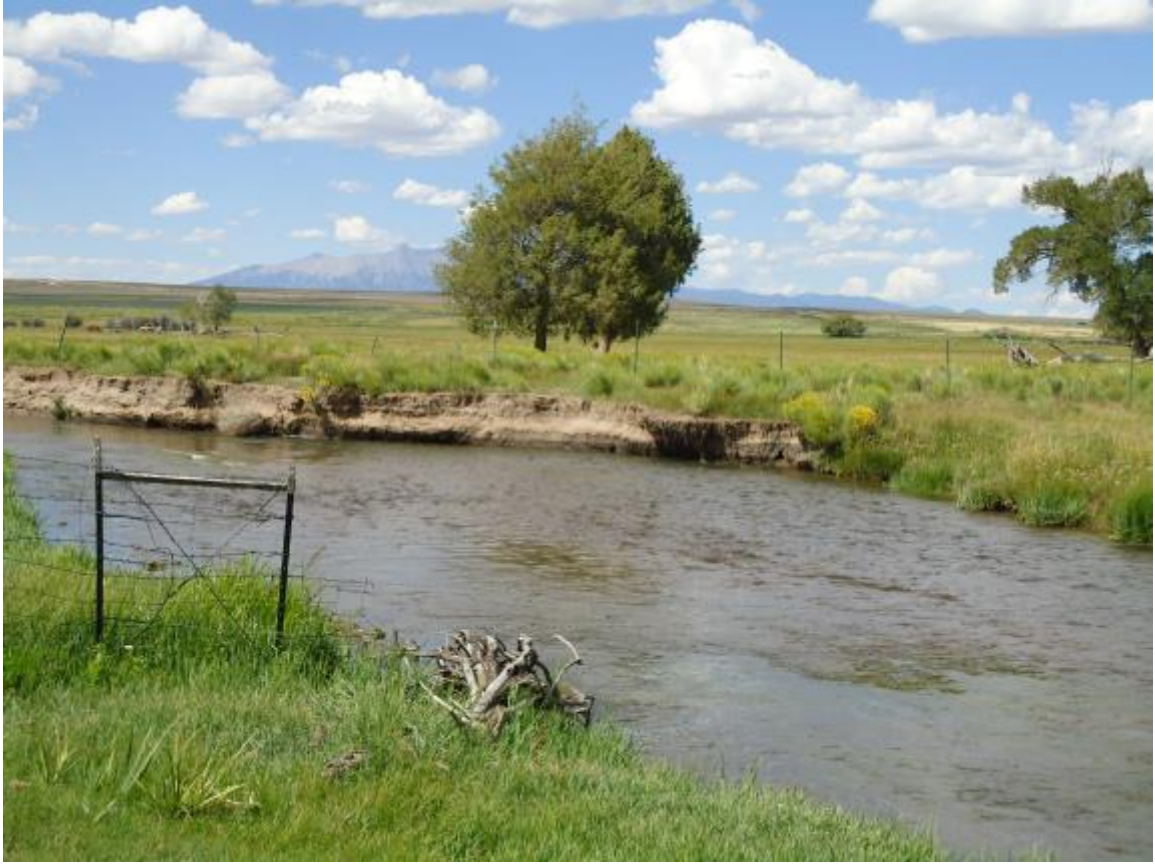
1. Riparian Areas: We found fairly severe stream bank erosion and the associated decline of the native cottonwood *bosque* (forest or woodland) along a short fifty-yard stretch of the Culebra River closest to the bridge crossing. This appears to be a consequence both of natural flood events and years of over-grazing and neglect of the control of livestock access points on the river for their drinking water. The bosque was found to be in very poor condition with a population of perhaps two-dozen mature (50-75 year-old) trees and very few successional saplings or juvenile trees. The cottonwood bosque is threatened with collapse due to grazing pressures that have prevented natural regeneration along the root channels for several decades.

Figure 4. Eroded riverbank on Culebra River at Almunyah de las Dos Acequias.

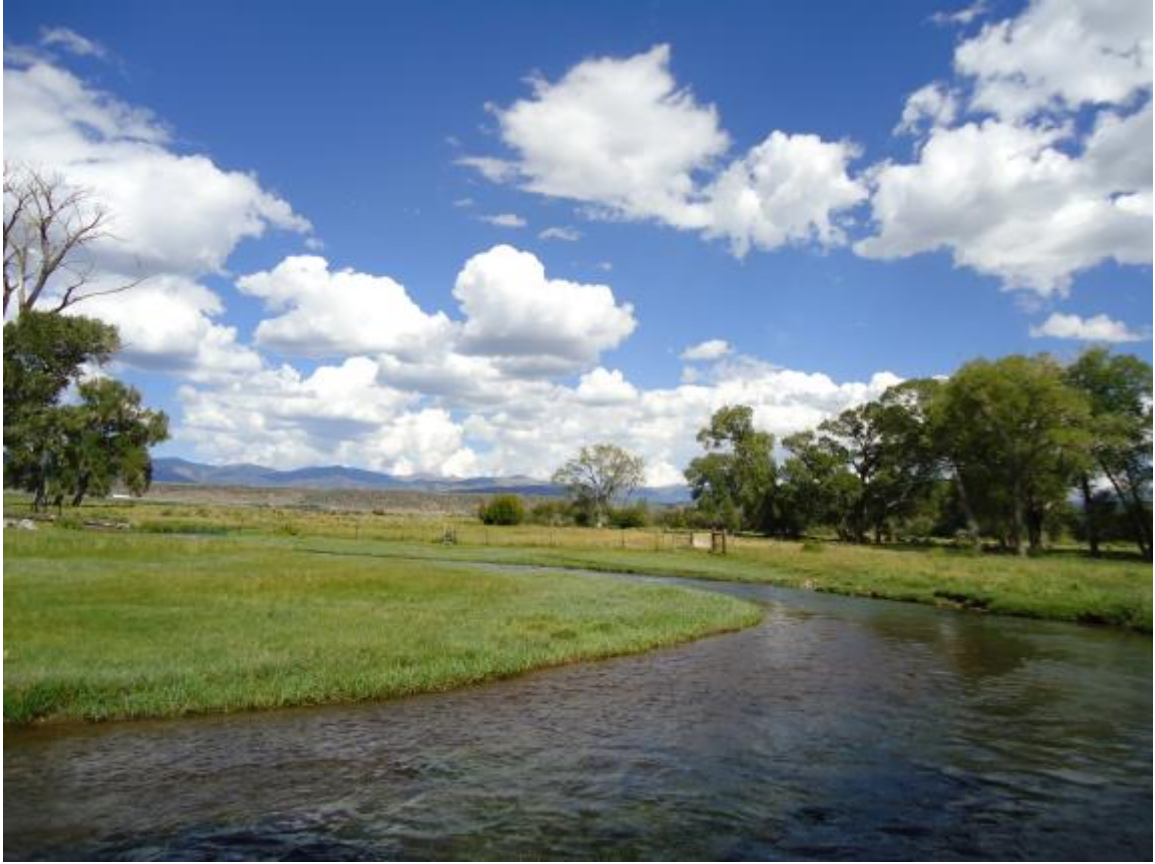
Figure 5. Stable meander banks on Culebra River at Almunyah de las Dos Acequias.
